OBSERVATIONS AND RECOMMENDATIONS
FOR
SALMON HABITAT ENHANCEMENTS
IN SELECTED ICELANDIC RIVERS

Scott D. Wenger

January 1989

In cooperation with Veithimalastofnun
Reykjavik, Iceland

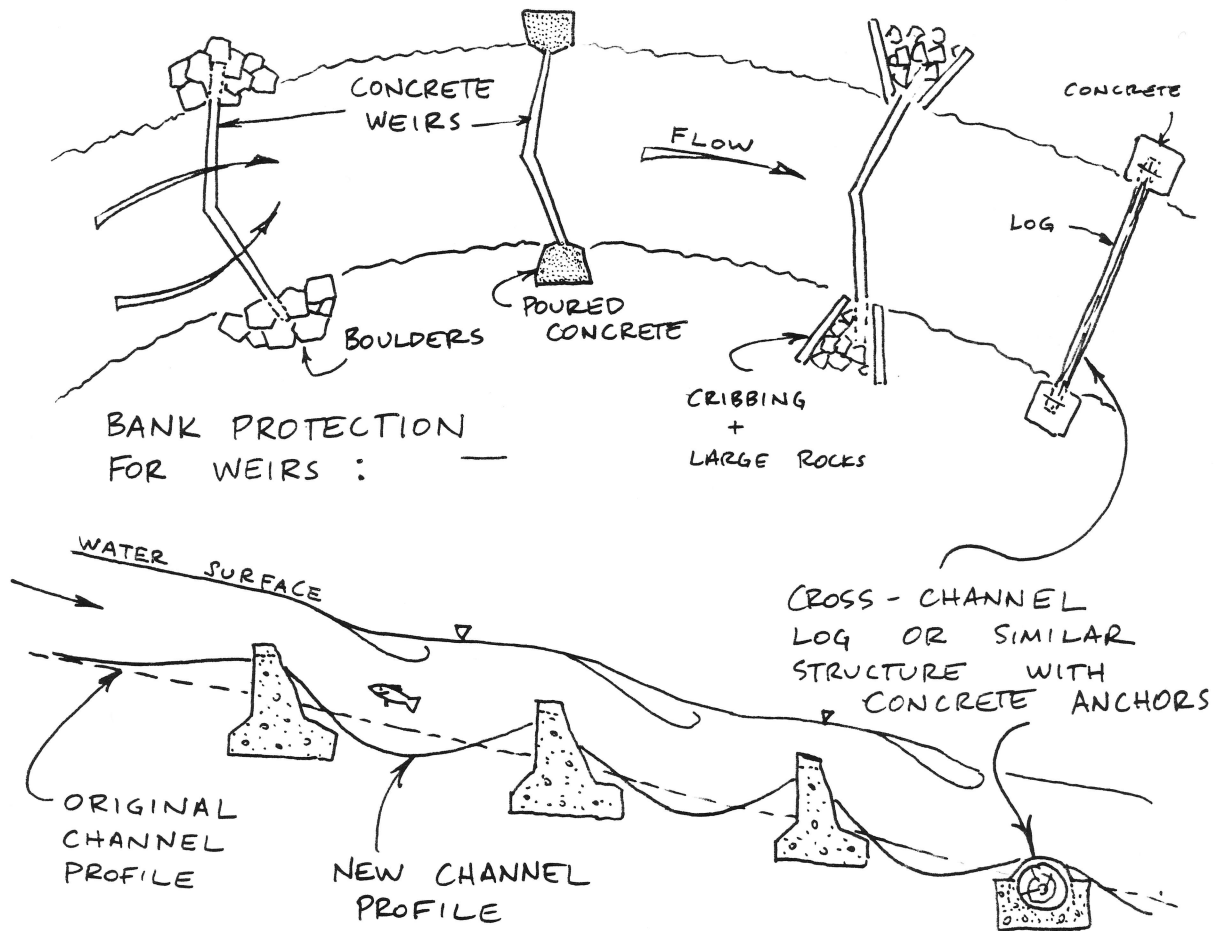
Figure 5.

CHANNEL STABILIZATION

WEIR SPACING AND HEIGHT TO BE DETERMINED BY DESIGN

(VERTICAL SCALE EXAGGERATED FOR CLARITY)

WEIRS AND LOGS EMBEDDED IN THE CHANNEL SUBSTRATE CAN BE USED TO FLATTEN THE SLOPE AND RETAIN ROCKS AND GRAVEL FOR FISH HABITAT

Habitat enhancement in Svarta requires the stabilization of the river through dissipation of stream energy by using stepped weirs and elevation controls embedded in the substrate. See figure 5. Weir spacing and weir heights are determined by a channel survey and flow analysis.

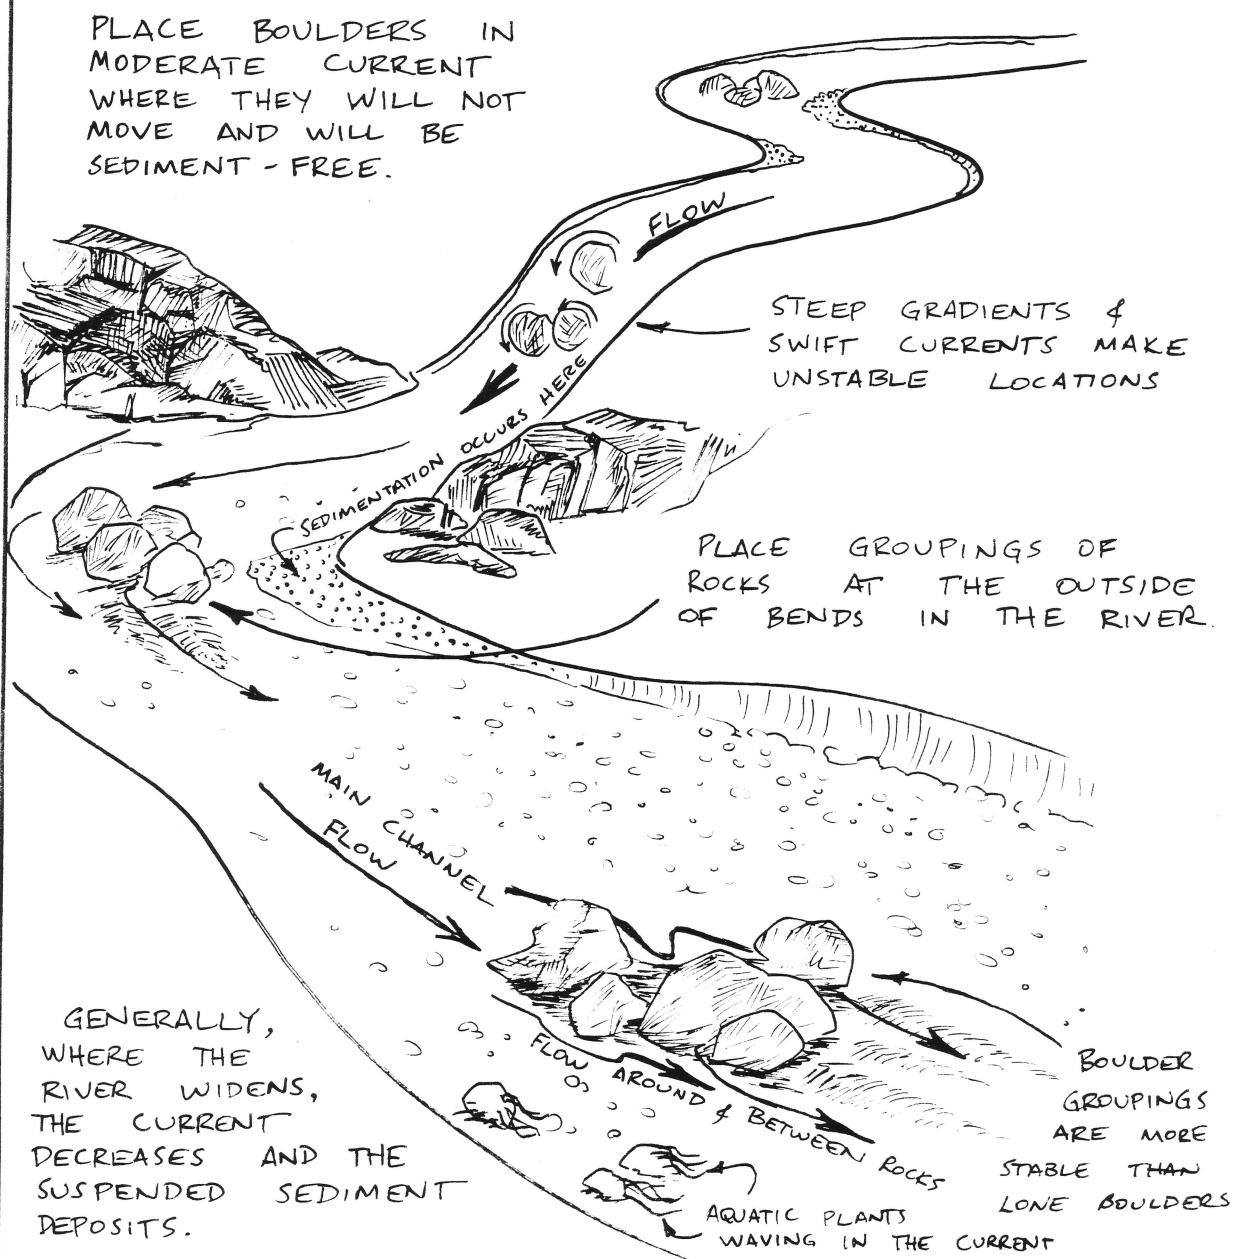
Figure 11.

BOULDER PLACEMENT FOR JUVENILE SALMON HABITAT

IN THE WIDE, FLAT PORTIONS OF THE RIVER PLACE ROCKS WHERE THERE IS A VISIBLE CURRENT. THESE ROCKS WILL NEED TO BE MOVED AROUND TO RELEASE THE SEDIMENT WHICH ACCUMULATES - ONCE EACH SPRINGTIME OR AS NEEDED. OR -

ADD MORE BOULDERS AS THE EARLIER BOULDERS ARE SEDIMENTED.

Within the main river channel of Hitara, sufficient flow is present for juveniles, although the substrate is uniform and embedded in sediment. Cover could be provided by adding rocks and boulders to the river from the surrounding hillsides. Boulder groupings are more stable than individual rocks. See figure 11.

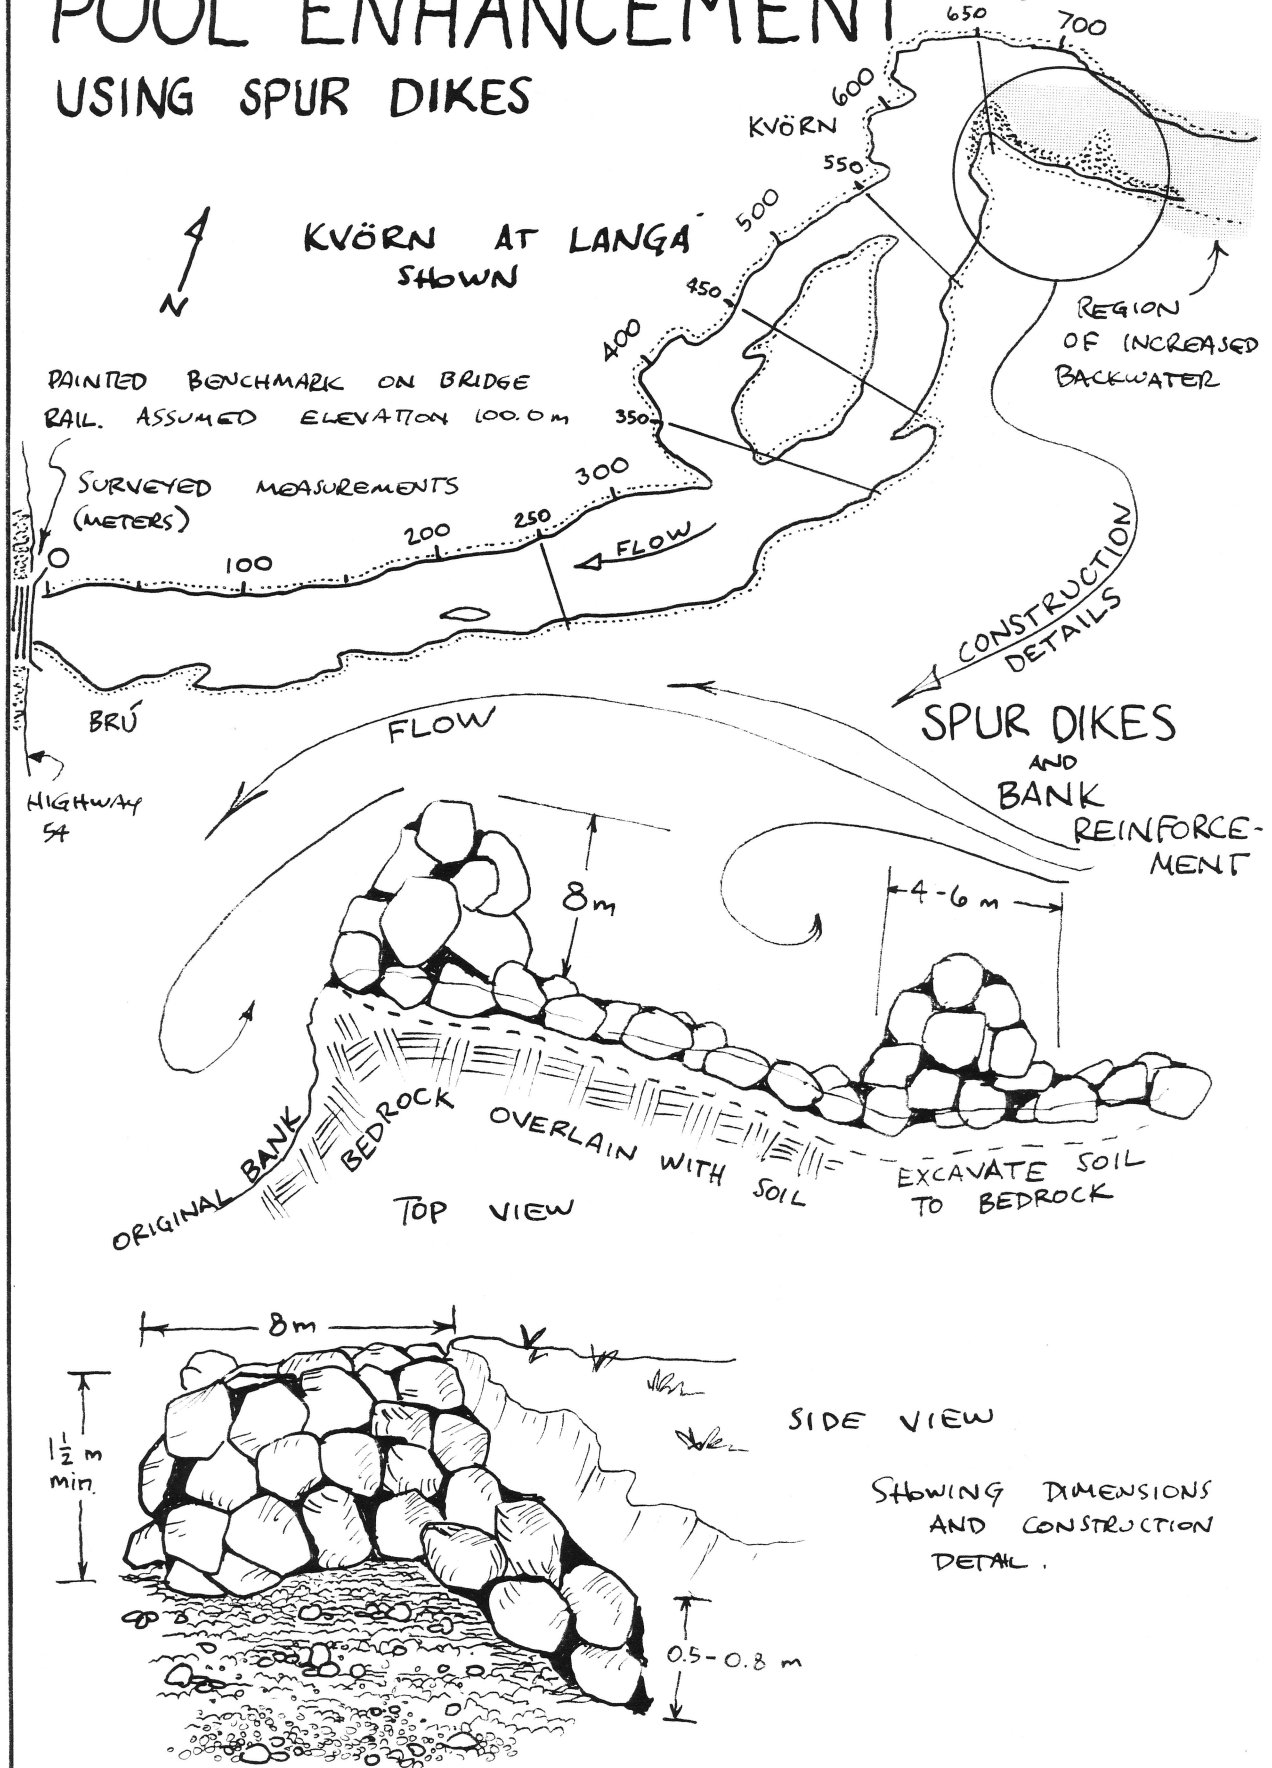
Figure 16.

POOL ENHANCEMENT USING SPUR DIKES

Spur dikes made of boulders are recommended to direct flow and shape the channel at Kvorn, as shown in figure 16. The spur dikes are located so that bank erosion will be minimal and so that the upstream water depth will be increased no more than 30 cm during mean flow.

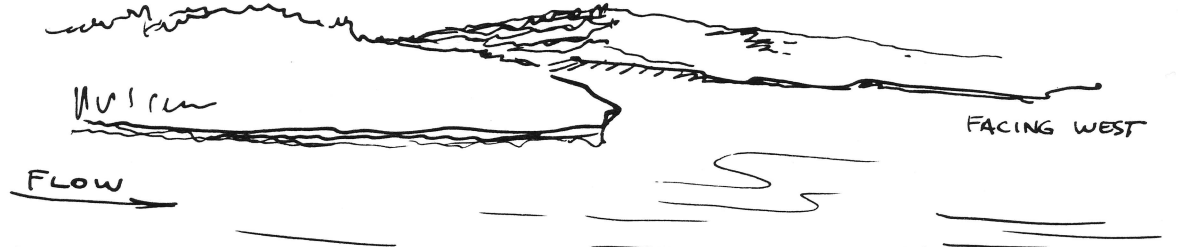
HABITAT BUILDING IN LAXÁ I ADALDAL

ADULT HABITAT
200 M UPRIVER
FROM MÖSUND

STACK BOULDERS
IN WATER DEPTHS
OF 2 M OR MORE

Given the observed velocities in the lake, (relatively swift for a lake, as such) boulder placements in water depths greater than 2 meters are recommended to encourage salmon groupings. Figure 30 illustrates a typical boulder stack, as well as a vane device which has been used in lakes and saltwater for attracting fish.
